**REPORT NUMBER: NCAP-MGA-2008-003**

**NEW CAR ASSESSMENT PROGRAM  
FRONTAL BARRIER IMPACT TEST**

**FORD MOTOR COMPANY  
2008 FORD MUSTANG CONVERTIBLE  
NHTSA NUMBER: M80207**

**PREPARED BY:  
MGA RESEARCH CORPORATION  
5000 WARREN ROAD  
BURLINGTON, WI 53105**

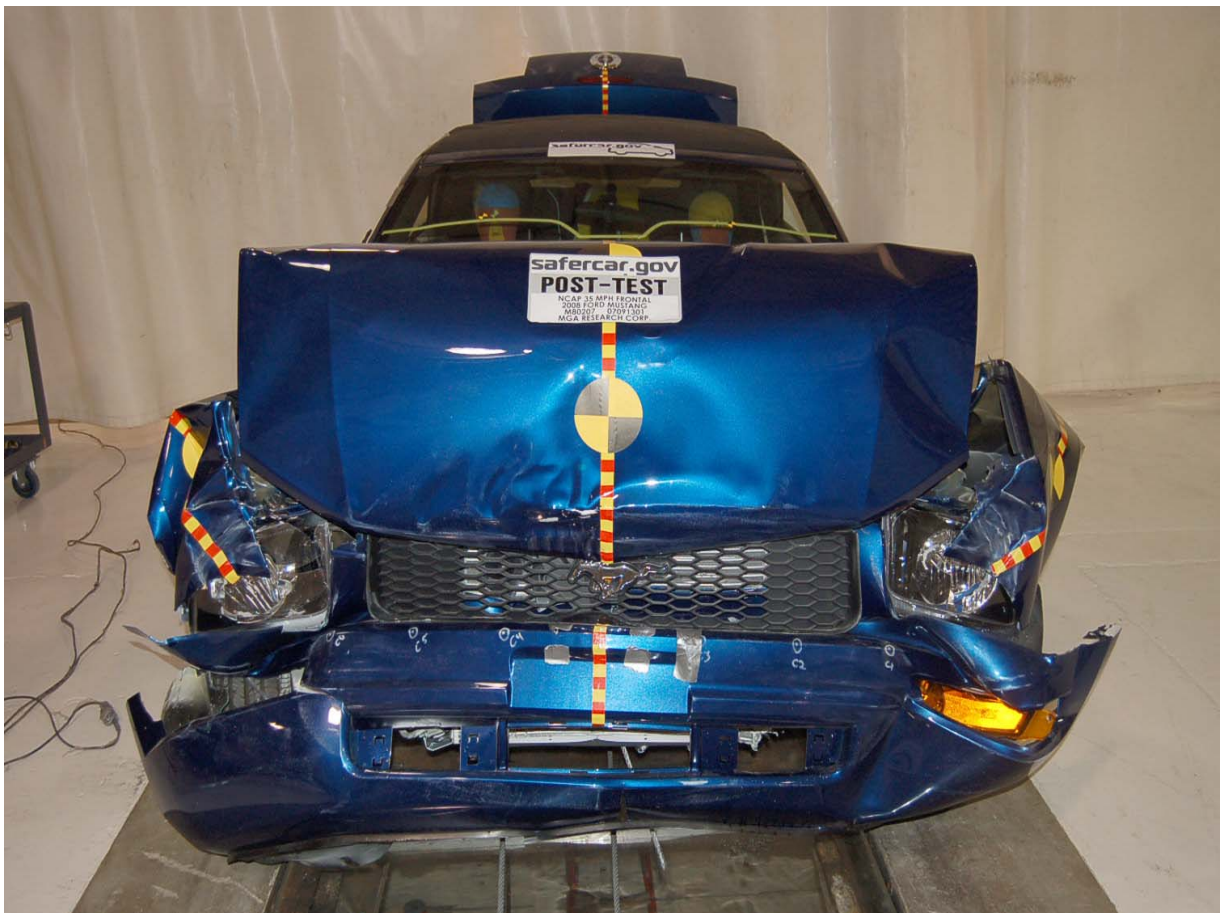
Post-Test Front View

The maximum static crush of the vehicle was 441 mm and both the driver and passenger side doors remained closed and latched during the impact event and were operable after the impact.

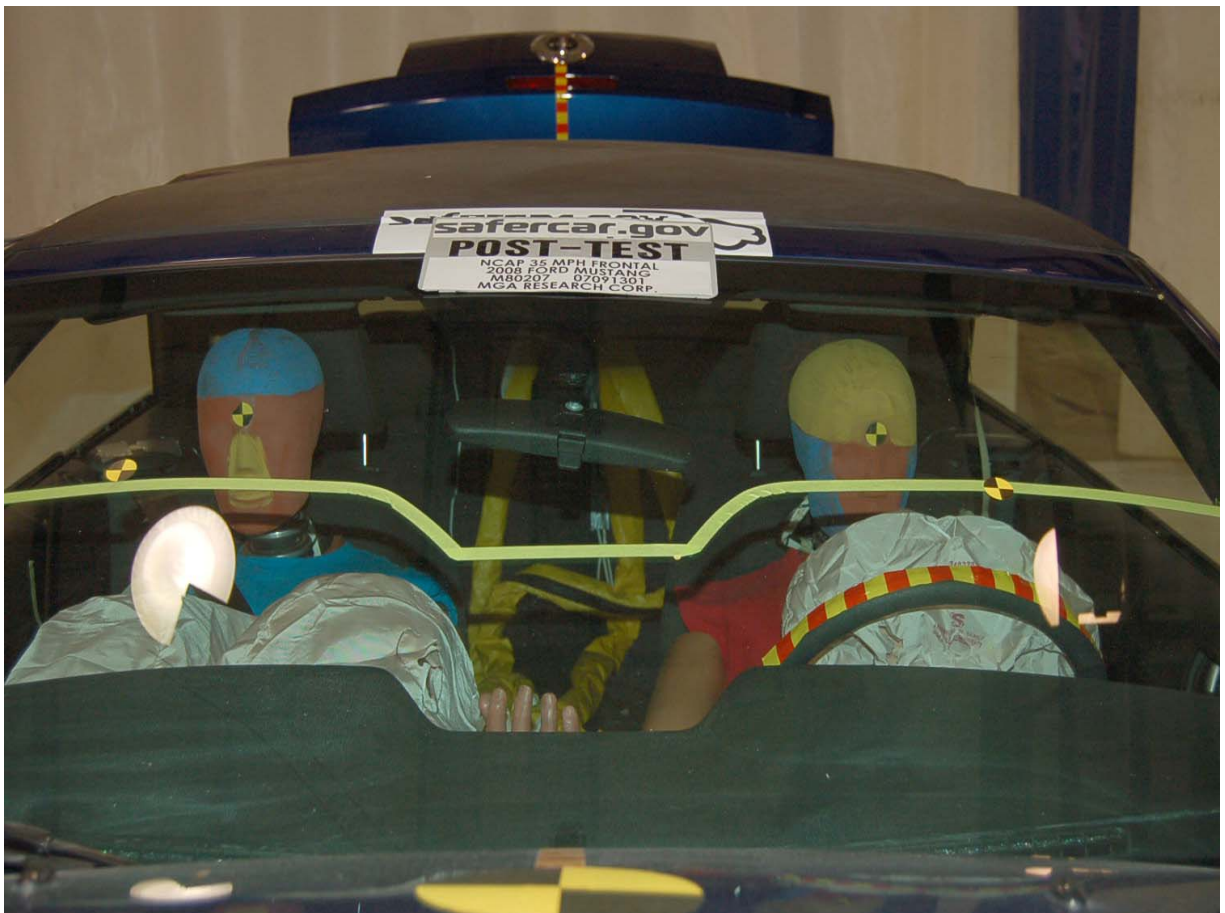
Post-Test Windshield View

There was 100 percent windshield retention and no intrusion into the protected zone of the windshield during the event. There was no Stoddard Solvent leakage after the event or during any phase of the static rollover.

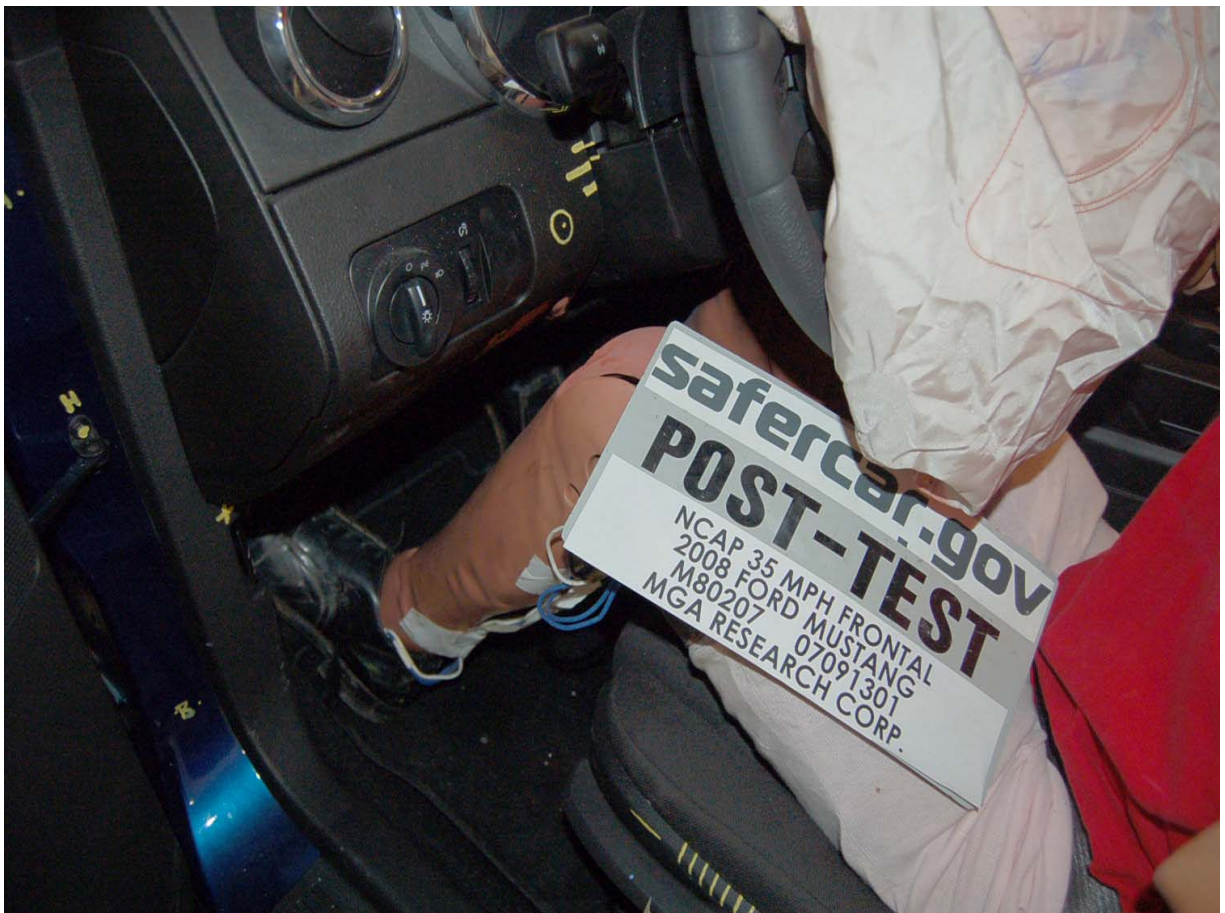
Post-Test Driver Side Knee Bolster

The driver's head and chest contacted the airbag. The driver's head also contacted the headrest. The driver's knees contacted the knee bolster. The passenger's head and chest contacted the airbag. The passenger's head also contacted the headrest. The passenger's knees contacted the glove box.
